NASA TM X-3412

FULL-SCALE CRASH TEST
OF A CH-47C HELICOPTER

Claude B. Castle

Langley Research Center

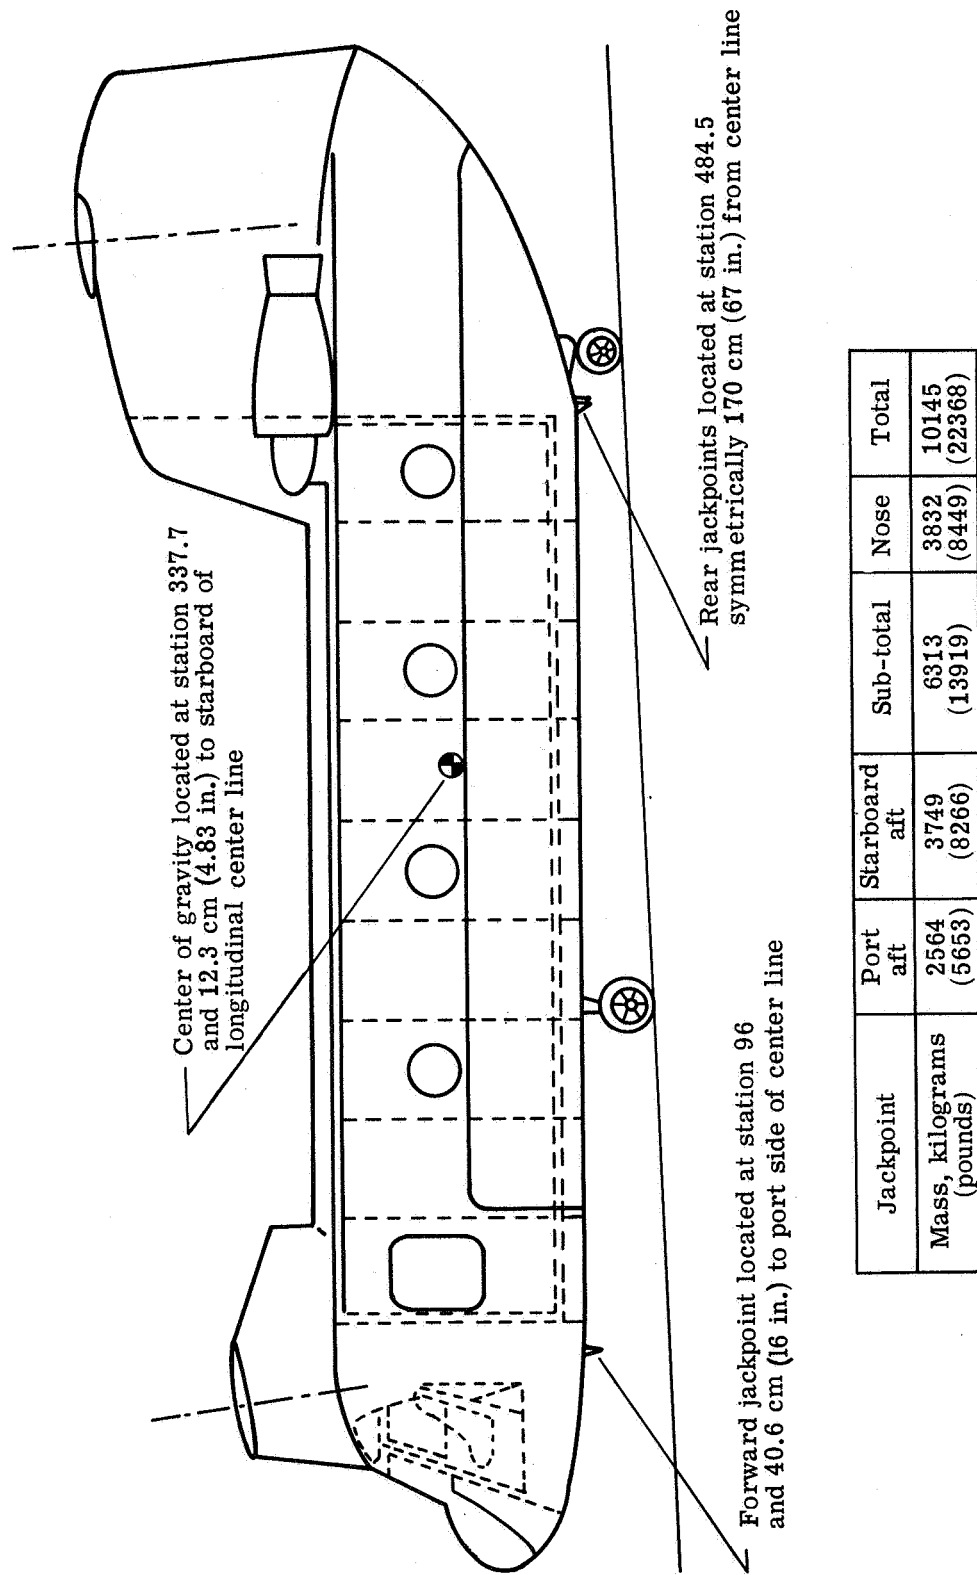
Figure 6.- Mass distribution for test specimen.

The starboard aft landing gear made the first contact with the impact surface. A slight roll was caused by the increased mass on the starboard side as shown by the mass distribution in figure 6. As impact progressed, the aft pylon crushed the aft cabin section and intruded into the aft cabin section approximately 1 m (3.3 ft), as indicated in figure 16. In addition, the relative upward movement of the rear cabin floor in response to the rigid impact surface, coupled with the downward movement of the pylon section, completely closed the aft end of the helicopter (fig. 16(a)). The asymmetrical crushing and starboard list of the vertical sections indicate again the effect of roll and mass asymmetry. Figures 16(b) and 16(c) are closeup photographs of the section at the starboard side and the port side aft landing gear, respectively. It is evident that the impact caused both rear landing-gear tires to rupture and the landing-gear support structure to collapse. The cabin section (fig. 17) was torn by both engines, and these large concentrated masses produced a shearing failure of the aft section of the helicopter. The interior view of the cabin section, looking aft (fig. 16(d)), also indicates the combined effect of a roll attitude and the upward and downward forces applied during impact. The two posts shown are deflection indicators and did not contribute to the structural support of the helicopter: the posts indicated a closure of approximately 0.75 m (29.5 in.) on the starboard side and 0.48 m (18.75 in.) on the port side. The helicopter continued to pitch downward during impact, and the effects of the forward landing gear on the forward cabin section are shown in figure 18. The forward landing gear maintained its integrity (figs. 18(a) and 18(b)) and acted as a fulcrum for the fuselage; this condition caused the floor of the cabin section to be pushed upward as the nose made contact. The relative upward movement of the cabin floor section in the vicinity of the landing gear was approximately 0.68 m (2 ft). An

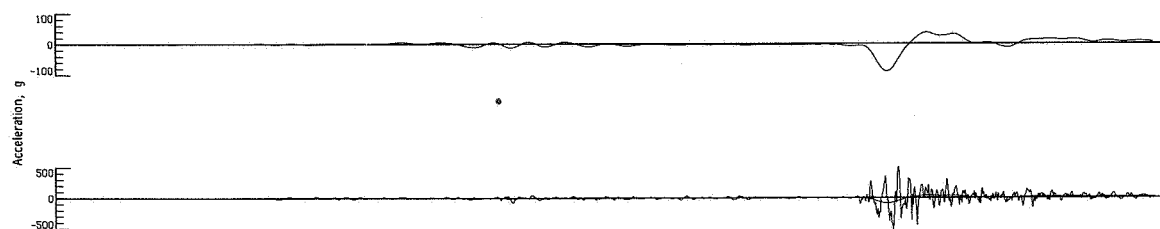
(b) Vertical accelerations at station 82.

Figure 15(b) shows the vertical acceleration data from an accelerometer mounted in the cockpit portion of the helicopter on the floor near the center line at station 82. The accelerations at this point show -20g during the crushing of the aft section (primary impact); then the accelerations increase to a peak of approximately -110g as the nose section slaps into the pavement.

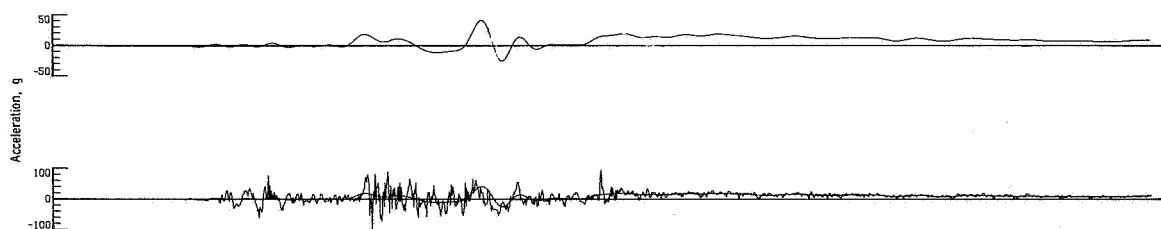
(c) Longitudinal accelerations at station 479.

Longitudinal time histories.- The longitudinal accelerations in the aft section (fig. 15(c)) were the highest when the aft section fractured at the cabin interface (fig. 14, frame 8). Accelerations of about 40g were recorded.

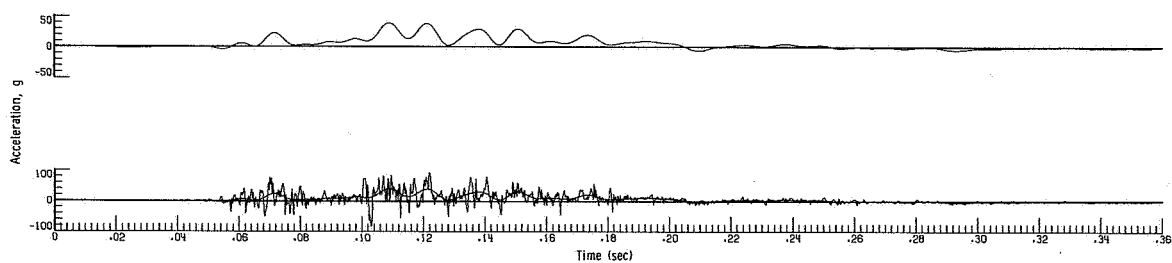
(d) Lateral accelerations at station 479.

Lateral time histories.- Figure 15(d) shows the effects of roll and mass distribution as the lateral accelerations oscillate about a positive value rather than zero. The lateral time histories indicate a maximum acceleration of approximately 40g.

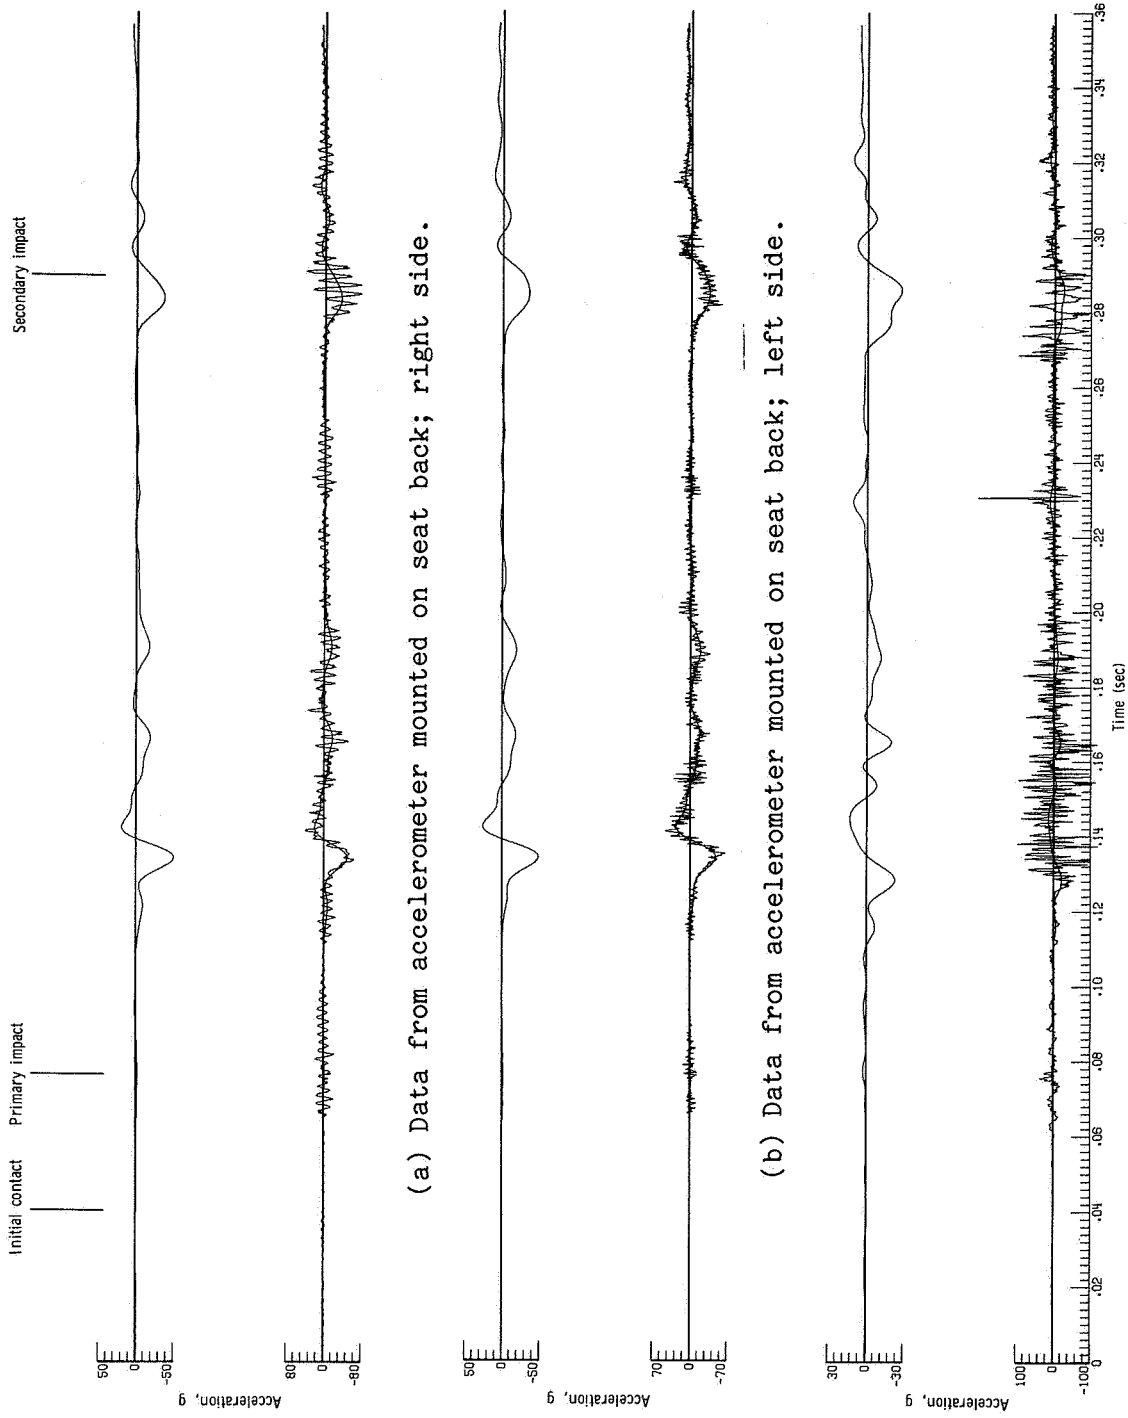
Figure 21.- Vertical accelerations for energy-absorbing crew seat.

Vertical time histories.- Typical accelerometer time histories for the energy-absorbing crew seat are shown in figure 21. Figures 21(a) and 21(b) show data taken from accelerometers mounted on the seat back at approximately the same vertical height (see fig. 10), whereas figure 21(c) shows data taken from the accelerometer mounted on the seat floor plate. The top trace in each figure is a least-squares fit (smooth curve) of the raw data. The second trace shows the smooth curve superimposed on the raw data. The smooth curves (fig. 21) show that the seat accelerometers indicate a reading of -50g on primary impact and approximately -40g on secondary impact. In comparison, the floor accelerometer indicated only -25g on primary impact and -30g on secondary impact.

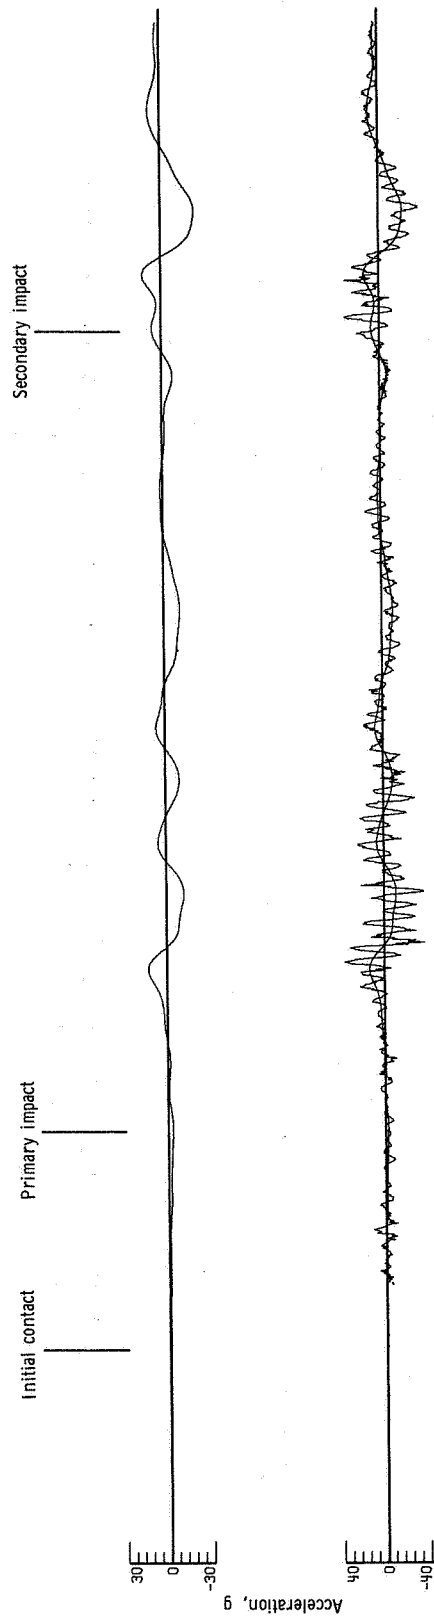
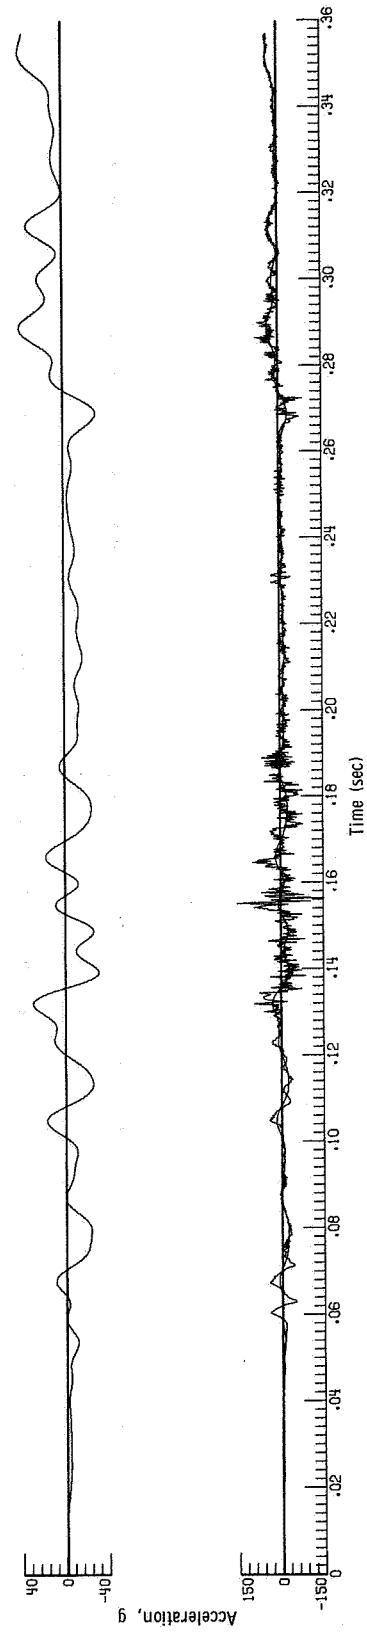
Figure 22.- Longitudinal accelerations for energy-absorbing crew seat.

Longitudinal time histories.- The longitudinal acceleration time histories from the energy-absorbing crew seat and its mounting floor plate are shown in figure 22. The smooth curve for the seat accelerometer indicates an initial acceleration of $\pm 12g$ and $-24g$ for secondary impact. The smooth curve for the floor plate accelerometer indicates a maximum of $\pm 32g$ for primary impact followed by a $\pm 40g$ for secondary impact. The data indicate that the seat received approximately 38 percent of the longitudinal accelerations recorded by the floor plate accelerometer at primary impact and 60 percent at secondary impact. Although there was no stroking of the energy absorbers, the elasticity of the clamping mechanism of the slider to the vertical guide rail did attenuate some of the acceleration input. Therefore, the energy-absorbing crew seat experienced some degree of acceleration attenuation in the longitudinal direction, but not through the designed energy-absorbing mechanism.

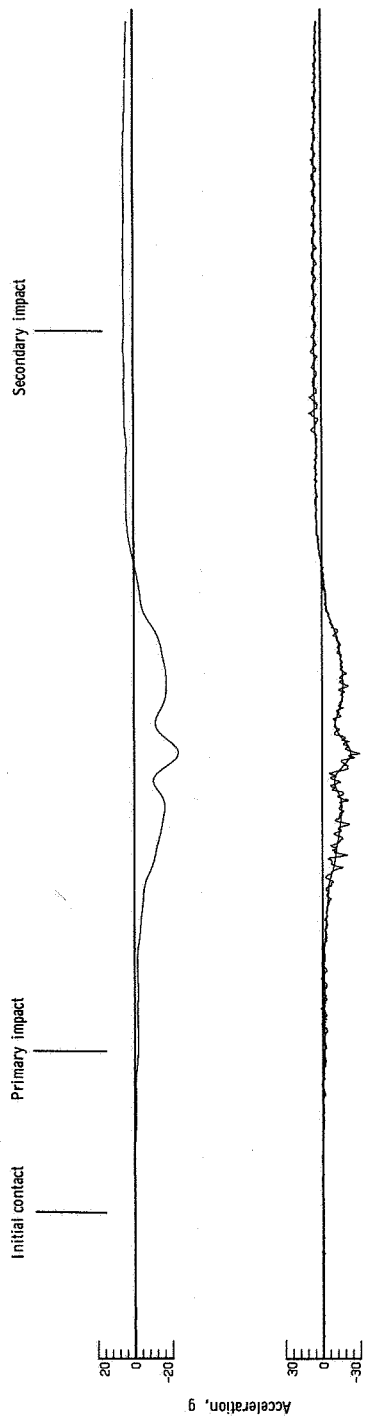
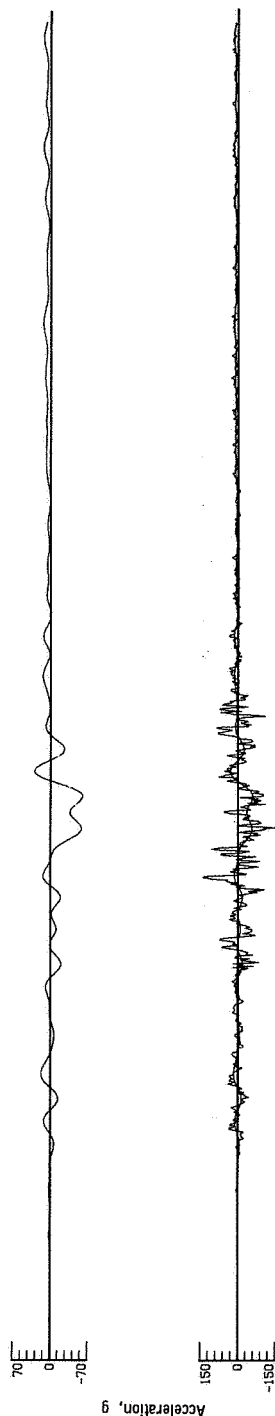
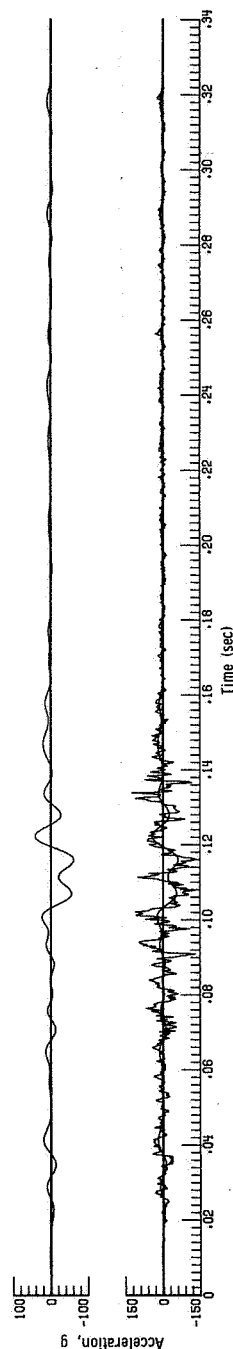
Figure 23.- Vertical accelerations for energy-absorbing troop seat.

Vertical time histories.- The accelerometer time histories from accelerometers located in the pelvic region of the anthropomorphic dummy in the troop seat and on the floor plate beneath the troop seat are shown in figure 23. The location of the troop seat (fig. 7) was such that the impact forces are significant only for the primary impact and not for the secondary impact. The crushing of the helicopter structure dissipated some of the energy between primary and secondary impact, and the accelerometer traces indicate only minute accelerations during secondary impact. These minute accelerations are not considered in the discussion of these traces.

The vertical accelerometer trace in the dummy (fig. 23(a)) indicates a maximum acceleration of -28g for the smooth curve. The smooth curve for the two floor accelerometers (figs. 23(b) and 23(c)) indicates -70g for the accelerometer mounted on the center line of the plate and -80g for the one slightly off the center line. The smooth curve data show that the dummy received about 40 percent of the forces experienced by the floor.

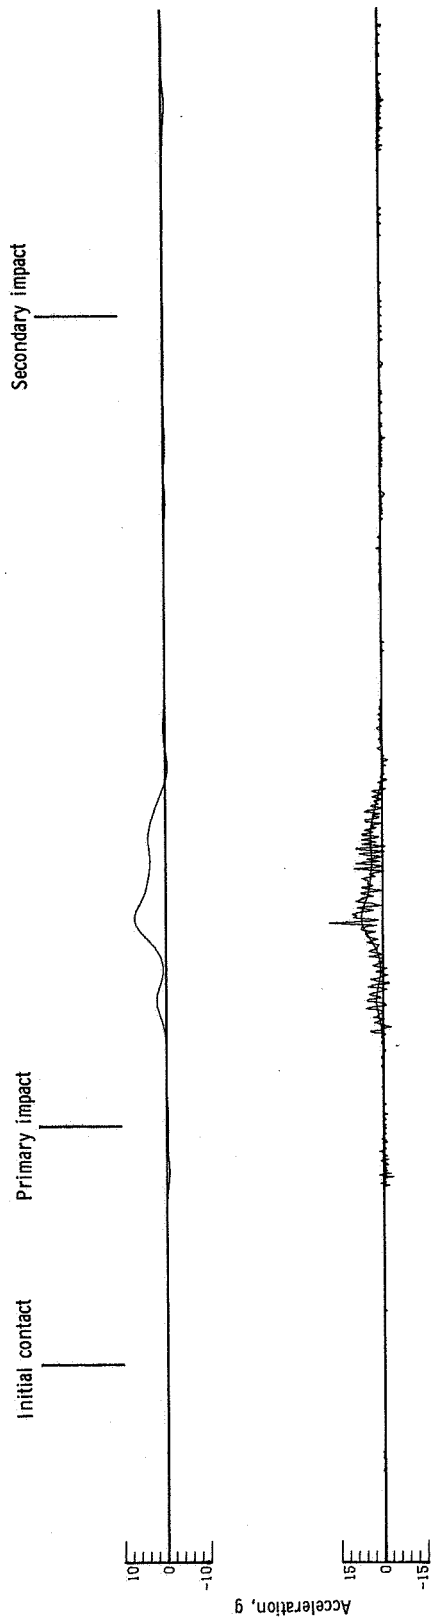
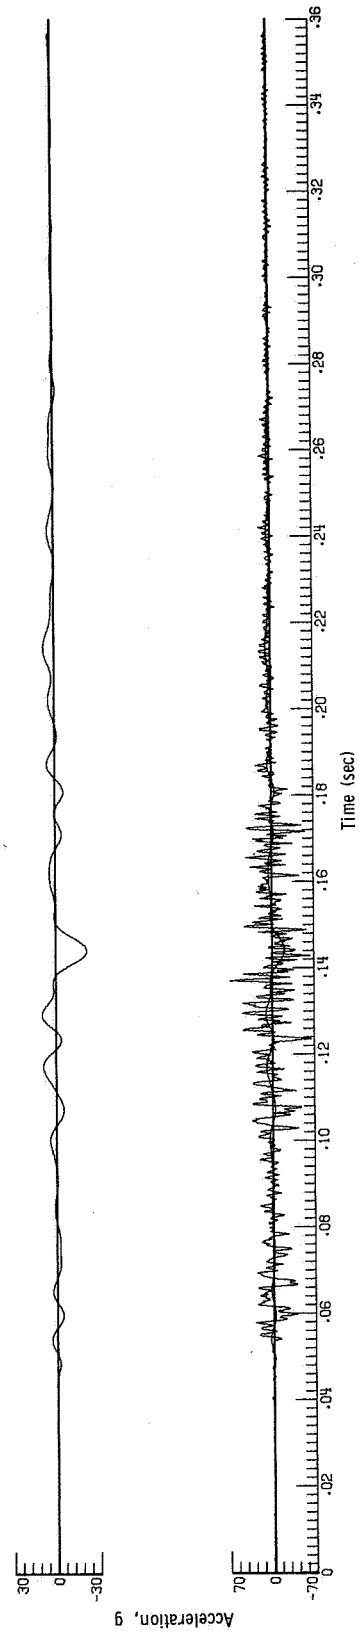
Figure 24.- Longitudinal accelerations for energy-absorbing troop seat.

Longitudinal time histories.- The longitudinal time histories for the accelerometers mounted in the dummy and on the troop-seat mounting plate are shown in figure 24. The smooth curve indicates that the dummy had an acceleration of 8g whereas the seat mounting plate had an acceleration of approximately -24g. The traces show that there was a reduction of acceleration of 66 percent between the floor plate and the dummy for the longitudinal accelerations.

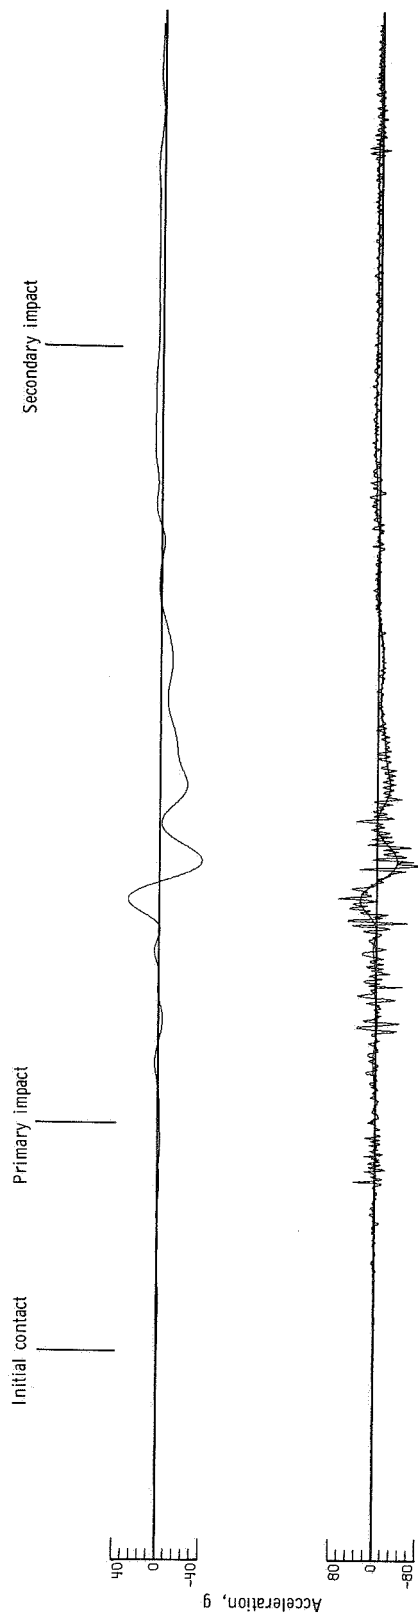
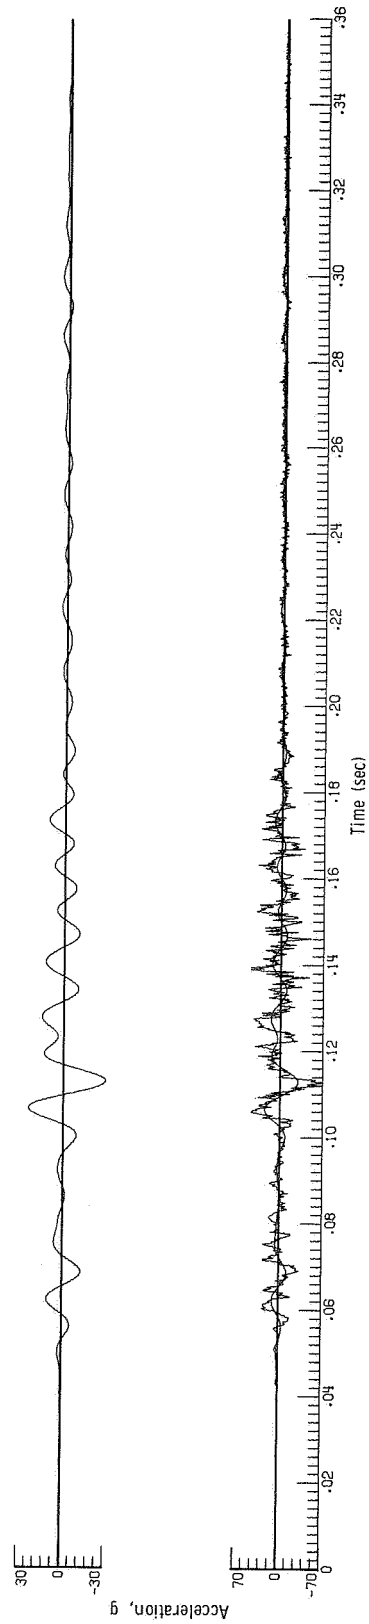
Figure 25.- Lateral accelerations for energy-absorbing troop seat.

Lateral time histories.- The lateral forces, shown in figure 25, indicate an increase of 33 percent in the dummy lateral accelerations over the accelerations of the floor plate. The smooth curves show $\pm 40g$ in the dummy and $\pm 30g$ in the floor plate. The lateral traces indicate that no lateral acceleration attenuation occurs in the seat as the seat is deflected vertically and longitudinally.
